Manhole Inspection Summary

Manhole # S29YY_031MH

Insp Date: **5/22/07 1:46 PM**

Location Address: **700 34TH ST**

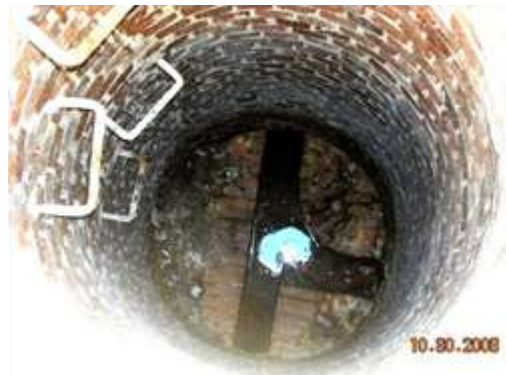
Top View

Evidence of surcharge - Bench debris.
Channel debris.

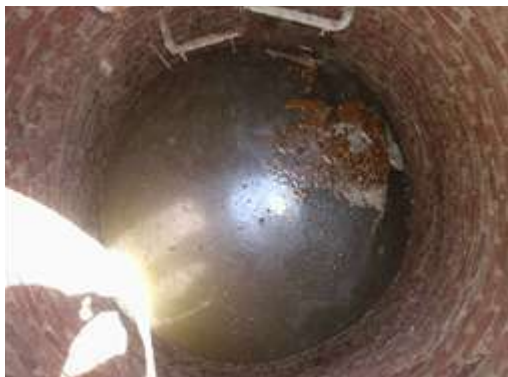
Top View

Active surcharge - 1st visit.

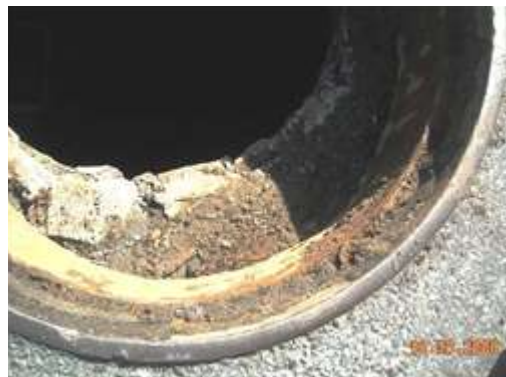
Defect

Frame leaks. Frame offset. Adjustment
infiltration.

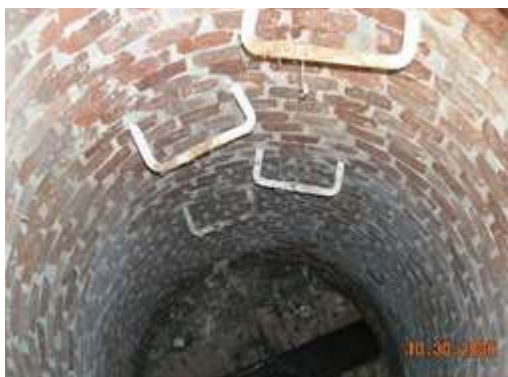
Defect

Adjustment and Barrel infiltration.

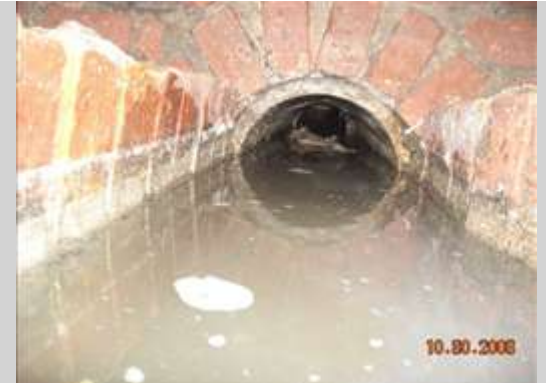
8 in. Circular Gravity Sewer Pipe Out @ 12 O'Clock

Infiltration: **Evidence** Pipe Seal Cond: **Unknown**

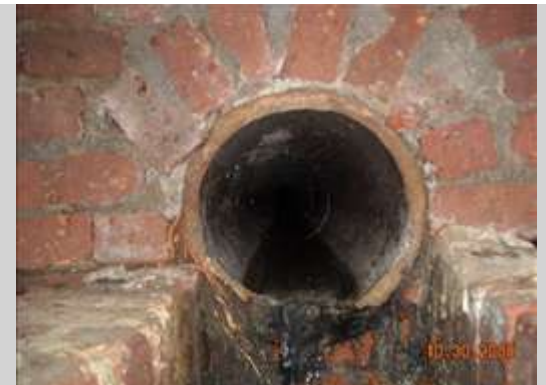
8 in. Circular Gravity Sewer Pipe In @ 3 O'Clock

Infiltration: **None** Pipe Seal Cond: **Roots**

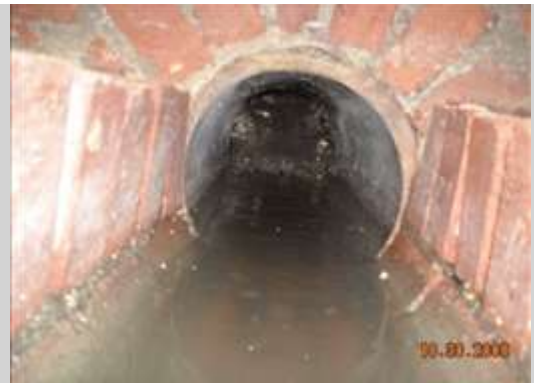
Pipe In @ 6 O'Clock

Channel deterioration.

Infiltration: **Evidence**

Comments **ORIGINAL INSPECTION BY PHOENIX ENGINEERING CREW: DP, SP 05/22/2007.
CLEANED AND COMPLETED BY REI/DRAYCO. ROOTS NEED TO BE REMOVED FROM
6 O'CLOCK PIPE; NO ROOT CUTTER ON FLUSHER TRUCK**
